MANUAL ON
“RETROFITTING OF EXISTING VULNERABLE
SCHOOL BUILDINGS – ASSESSMENT TO RETROFITTING”
PART I

This book is developed by Save the Children, Construction Quality & Technical Assistance (CQTA)

Center for Disaster Mitigation - Institute of Technology Bandung (CDM -ITB)

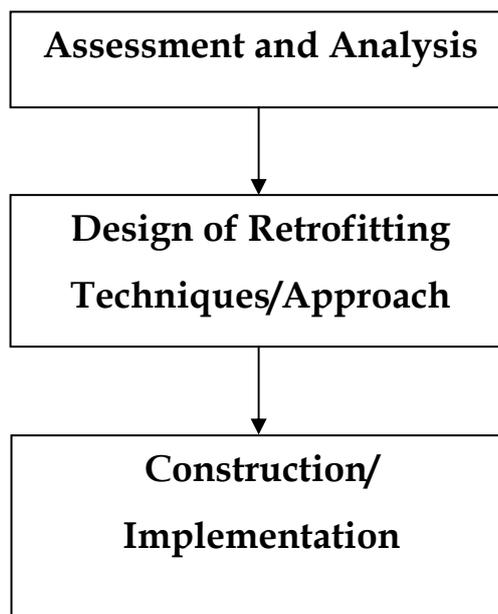
1. Assessment and Analysis
2. Design of Retrofitting Techniques/Approach
3. Construction/Implementation of Retrofitting

Figure 3 General Process of Retrofitting

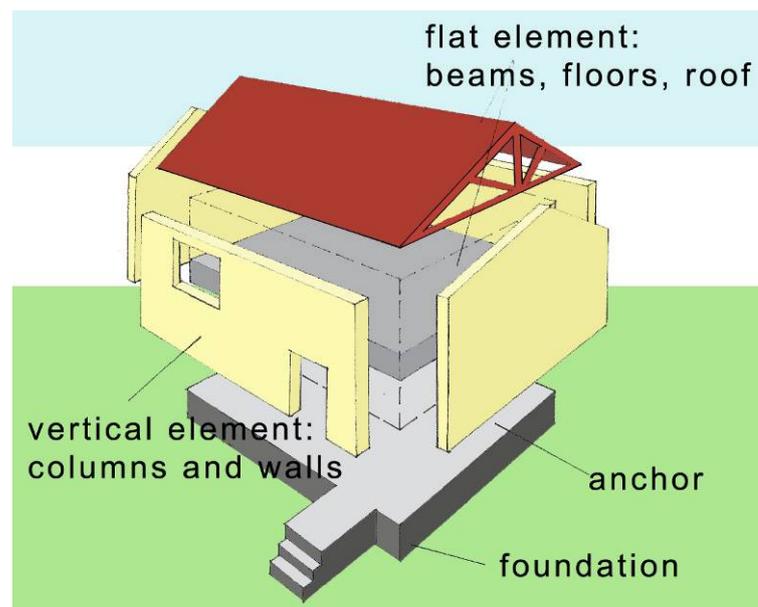
Before conducting the assessment, basic knowledge on the types of structural elements is a compulsory. Following is an illustration to describe the structural elements of building.

Figure 4 Structural Elements (Courtesy of *Panduan Konstruksi dan Perkuatan Bangunan Sekolah Tahan Gempa*, CDM-ITB 2008)

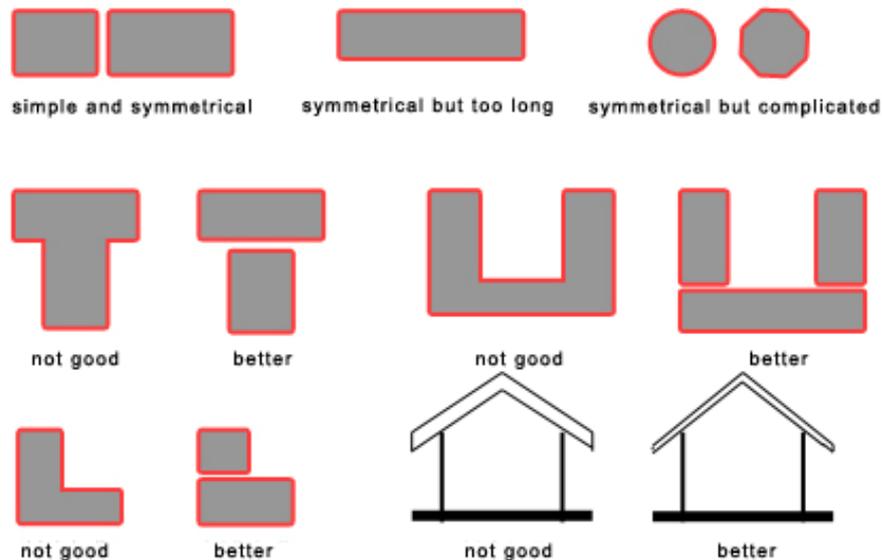
Simple and symmetrical layout will give a good performance of the building when subjected to earthquake loads. Rectangular or square building layout is categorized as a simple and

symmetrical building layout. When the layout is not symmetric, dilatation should be provided to separate the building. The following illustration describes typical building layout and their performance to earthquake forces.

Figure 5 Plan Configuration (Courtesy of *Panduan Konstruksi dan Perkuatan Bangunan Sekolah Tahan Gempa*, CDM-ITB 2008)

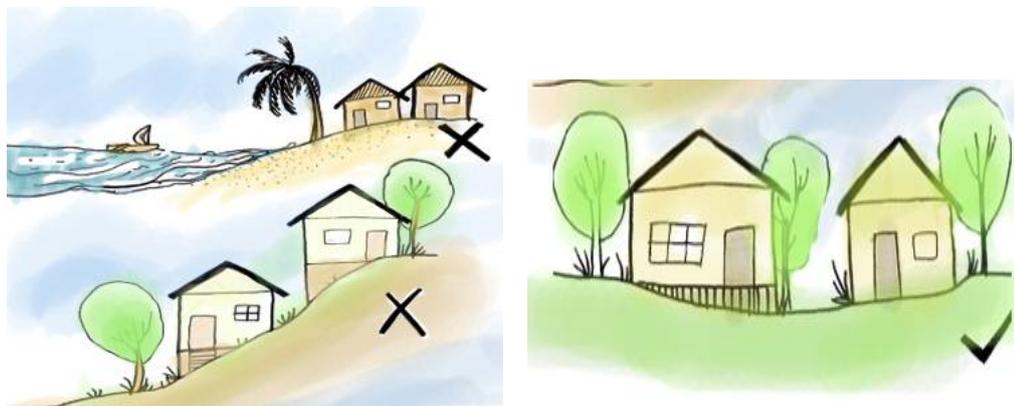
Some of the areas are prohibited for construction of building. Areas located on a slope and coastal areas are very vulnerable to natural disasters. It is also suggested not to construct a building on the sandy soil with thickness of more than 1 m, to prevent upraisal of building.

Figure 6 Site Condition (Courtesy of *Panduan Konstruksi dan Perkuatan Bangunan Sekolah Tahan Gempa*, CDM-ITB 2008)

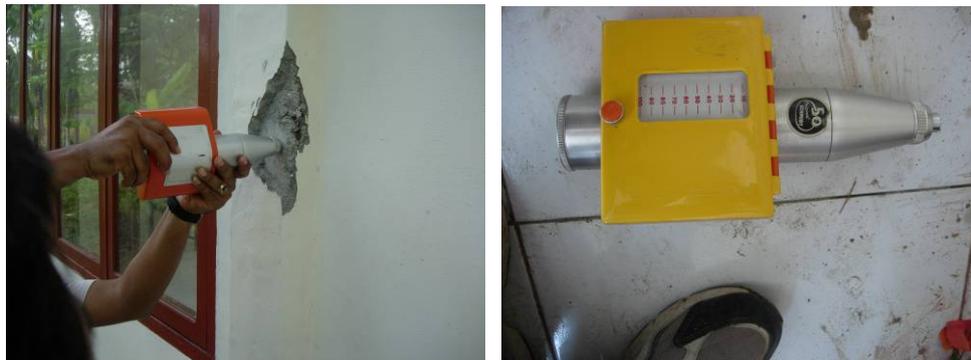
Non Destructive Test is conducted to assess the upper structure condition, and suggested to be conducted as much as possible to give proper description and evaluation on material properties. Some of the commonly used NDT are Schmidt Hammer Test and Ultrasonic Pulse Velocity Test (UPV). Schmidt Hammer Test is not intended to get the concrete strength directly, and a correlation formula should be used to obtain the

compressive strength. The procedure of Schmidt hammer test refers to ASTM C 805. Ultrasonic Pulse Velocity Test (UPV) is intended to check crack depths by measuring the concrete density. The procedure of UPV test refers to ASTM C 597.

Figure 9 Non-destructive Testing Tools

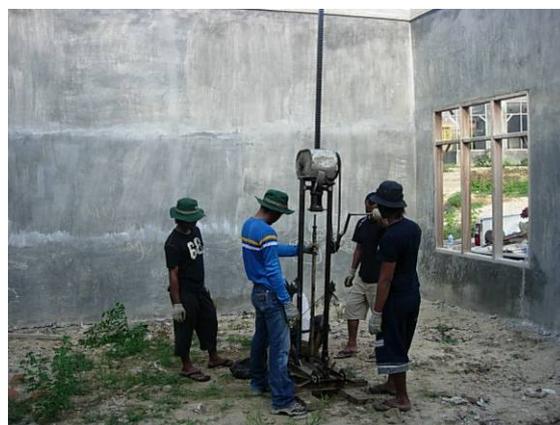
Structural investigation for sub-structure includes the investigation for soil properties and foundation. There are many techniques for investigating soil properties. The most common used techniques for single story structure are hand boring and soil penetration test.

Figure 10 Soil Penetration Test

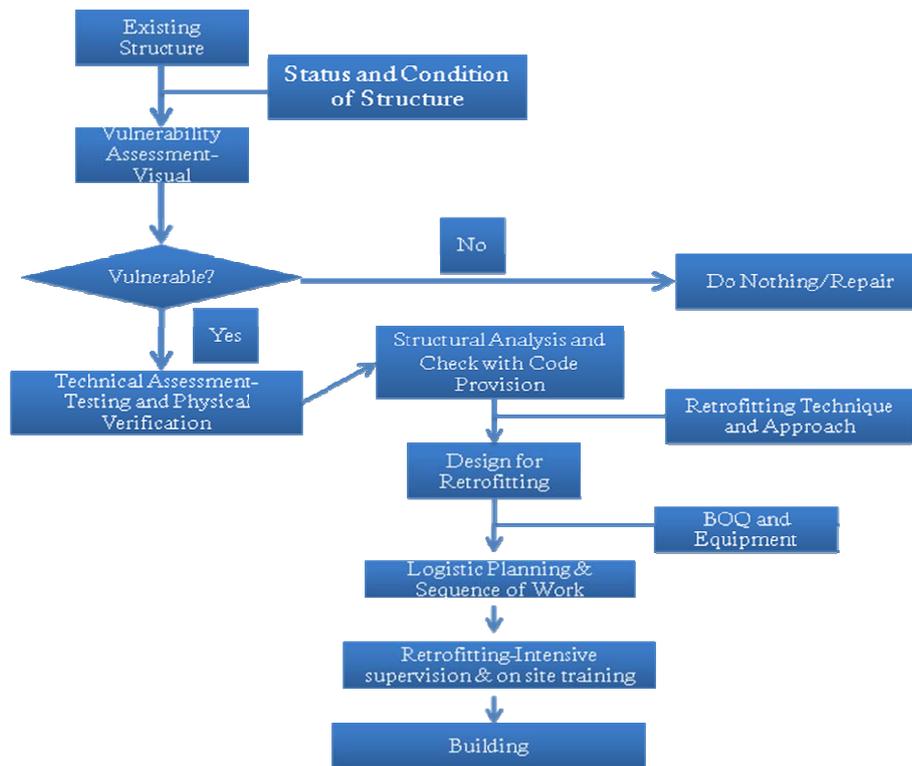
As explained in the previous chapter, retrofitting can be a favorable approach because of its advantages compared to reconstructing of buildings. There are several stages in the retrofitting process. The following chart describes the stages of retrofitting.

Figure 12 Retrofitting Stages

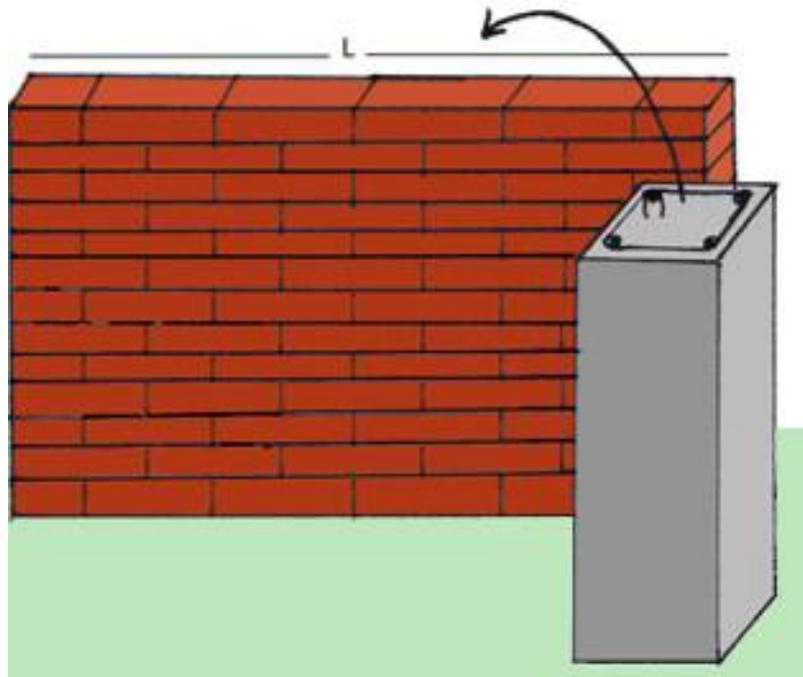
1. Force distribution is needed to reduce
2. Structural stiffness is needed to increase
3. Total area of wall without vertical structural element > 9 m²

Figure 13 Addition of Reinforced Concrete Column (Courtesy of *Panduan Konstruksi dan Perkuatan Bangunan Sekolah Tahan Gempa, CDM-ITB 2008*)

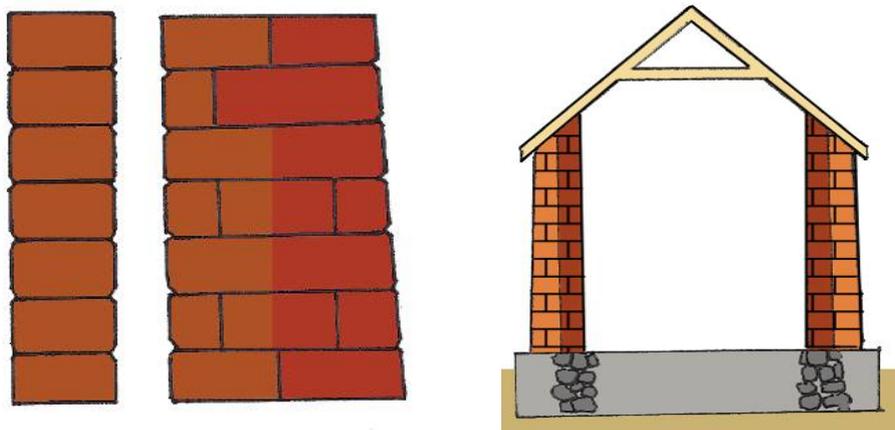
Figure 14 Addition of Buttress in Masonry Structure

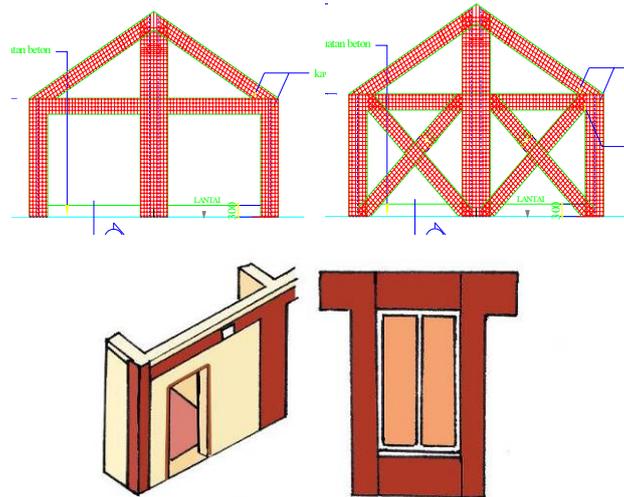
- 2) Implementing horizontal and vertical seismic belts (iron wire mesh) in masonry building
The iron wire mesh is usually implemented to strengthen the masonry walls. It is typically applied on the location of beam and column, and crossly applied at the edge portal of buildings. The wire mesh is applied at the both surface of masonry and the wire mesh is also anchored to maintain the position and integration

Figure 15 Strengthening with Seismic Belts

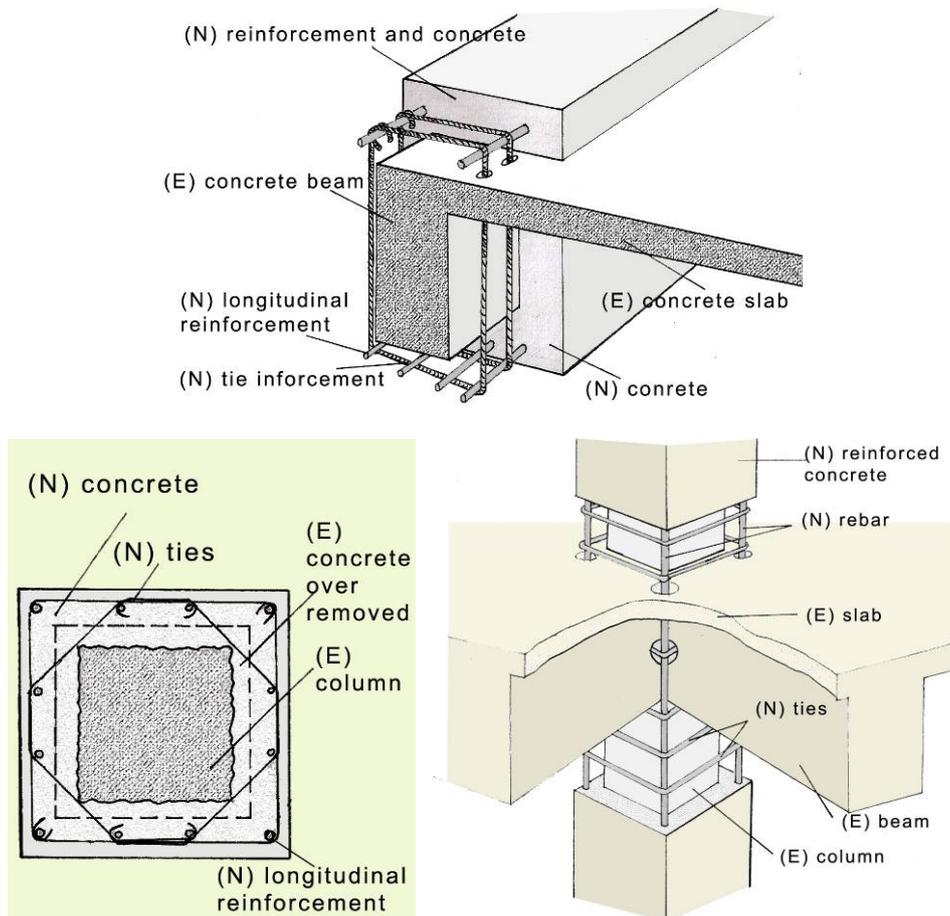
The concept of concrete jacketing is an addition of a relatively thick layer of reinforced concrete in the form of a jacket around the existing structural elements (usually columns). Jacketing will enhance the flexural strength, ductility and shear strength of the structural elements.

Figure 16 Concrete Jacketing

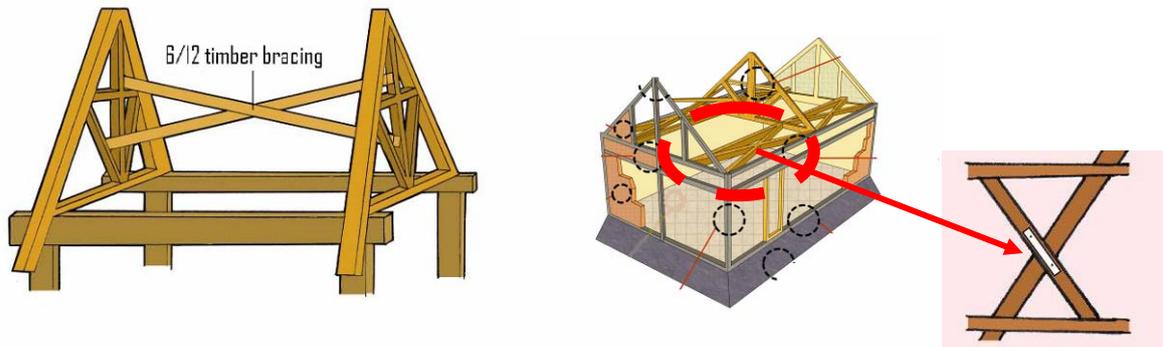
In strengthening the roof trusses, an addition of diagonal truss connecting two adjacent roof trusses will increase the stiffness of the roof diaphragm system. Moreover, adding the diagonal bracing in the same level of beam will also increase the stiffness of the roof diaphragms.

Figure 17 Strengthening Roof Trusses (left) and Roof Diaphragms (right) (Courtesy of *Panduan Konstruksi dan Perkuatan Bangunan Sekolah Tahan Gempa, CDM-ITB 2008*)

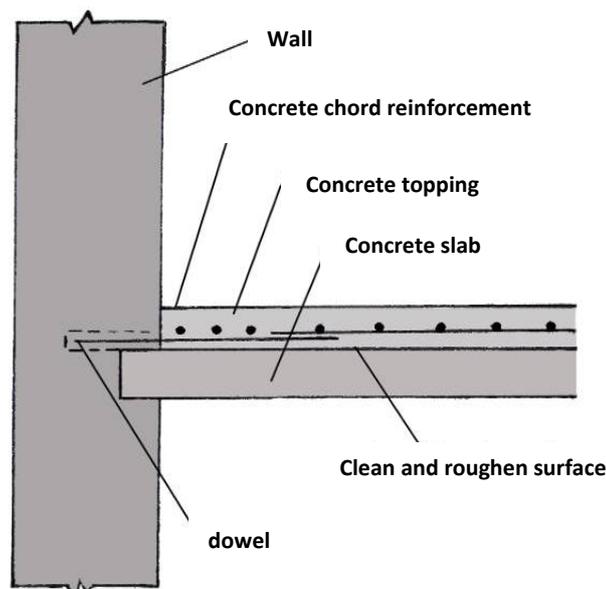
The major deficiencies found in the concrete diaphragm are inadequate in-plane shear capacity of the concrete diaphragm and inadequate flexural capacity. In strengthening shear capacity, overlaying the existing concrete diaphragm with new reinforced concrete topping slab and reducing the shear by providing supplemental vertical-resisting elements will improve the capacity. In strengthening the flexural capacity, casting a new chord member integral with the slab after removing the edge of diaphragm slab and reducing the flexural stress by providing additional vertical-resisting elements will improve the flexural capacity.

Figure 18 Strengthening Concrete Diaphragm with a New Topping Slab and Chord

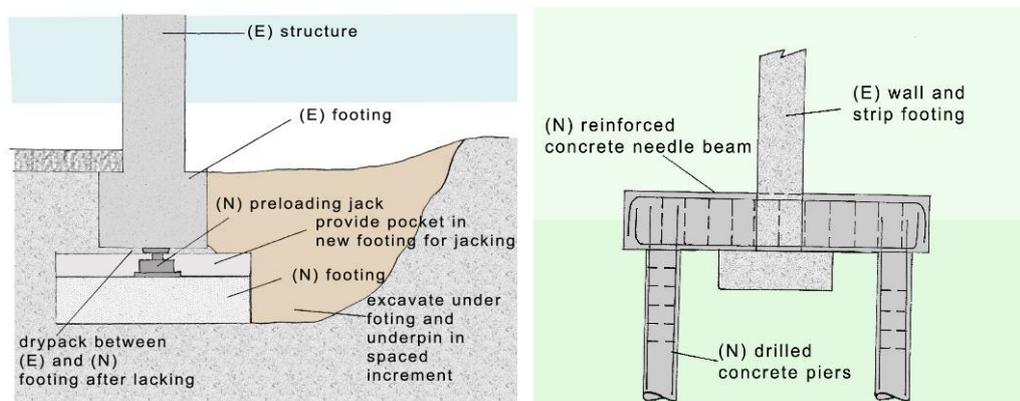
- Increasing the uplift capacity of the existing footing by adding drilled piers or soil anchors
- Increasing the size of the existing footing by underpinning to mobilize additional foundation and soil weight
- Reducing the uplift forces by providing supplemental vertical-resisting elements

Providing significant increase of uplift capacity is most effective by adding drilled piers or soil anchors. However, it should be noted that all interior foundation works will be costly and disruptive than exterior foundation works.

Figure 19 Underpinning of the Existing Foundation and Addition of Drilled Piers

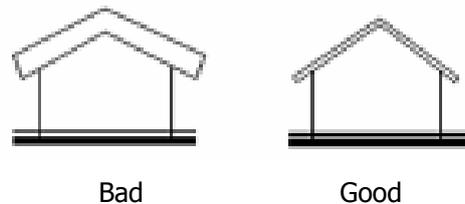
Many choices are available to decrease the demand on existing building. One of the simplest methods is reducing the weight of the building, hence it will decrease the earthquake load subjected to the building. Techniques that have been utilized to reduce weight include removing the upper stories of a building, changing the use of the buildings, replacing heavy roof system with light assembly roof system, and removing heavy appurtenance (such as parapets, balconies, water towers, or equipments).

Figure 20 Reducing the Weight of the Building by Using Light Weight Roof System

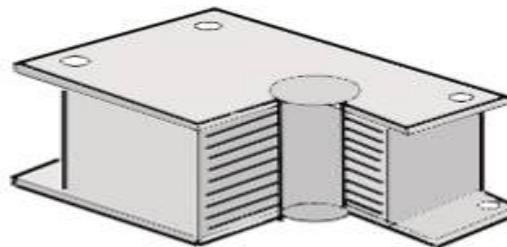
The other methods, more technical and relatively more expensive, also can be adopted by providing seismic isolator and supplemental damping to decrease the demand on the building.

Figure 21 Lead Rubber Bearing

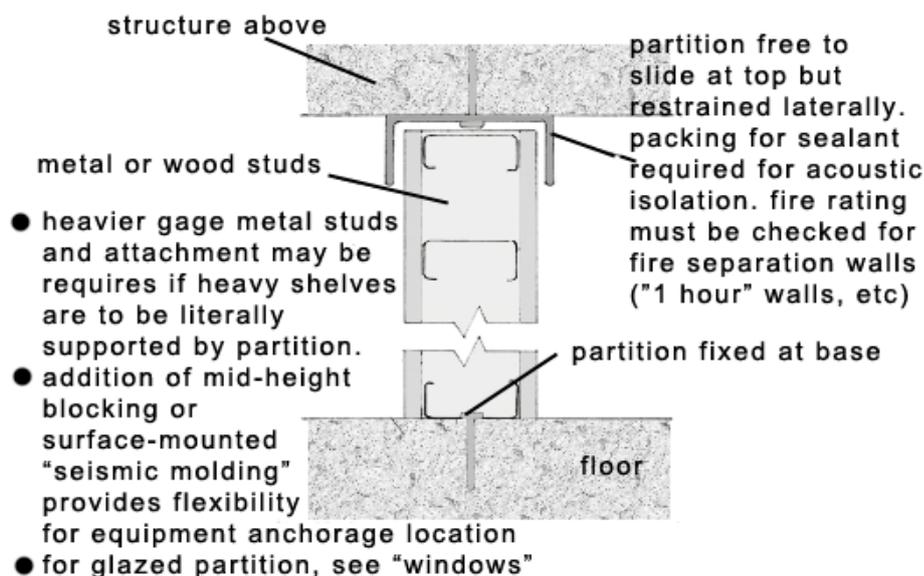
Figure 22 Built-in Full-Height Partition

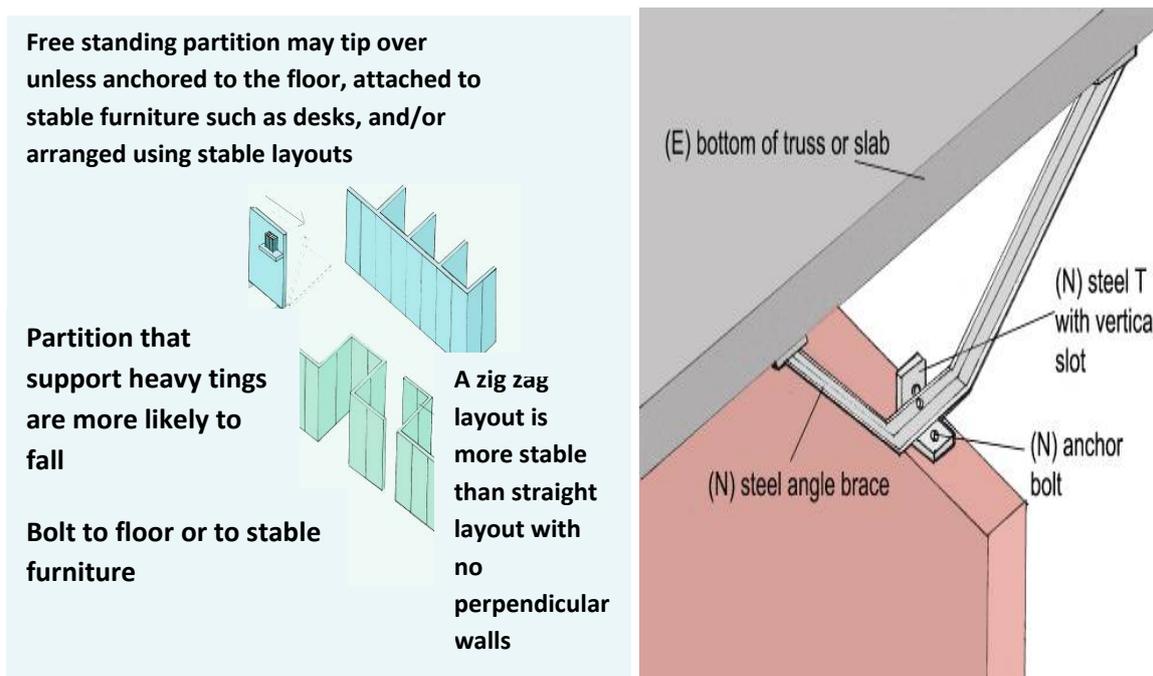
Figure 23 Built-in Partial-Height Partition

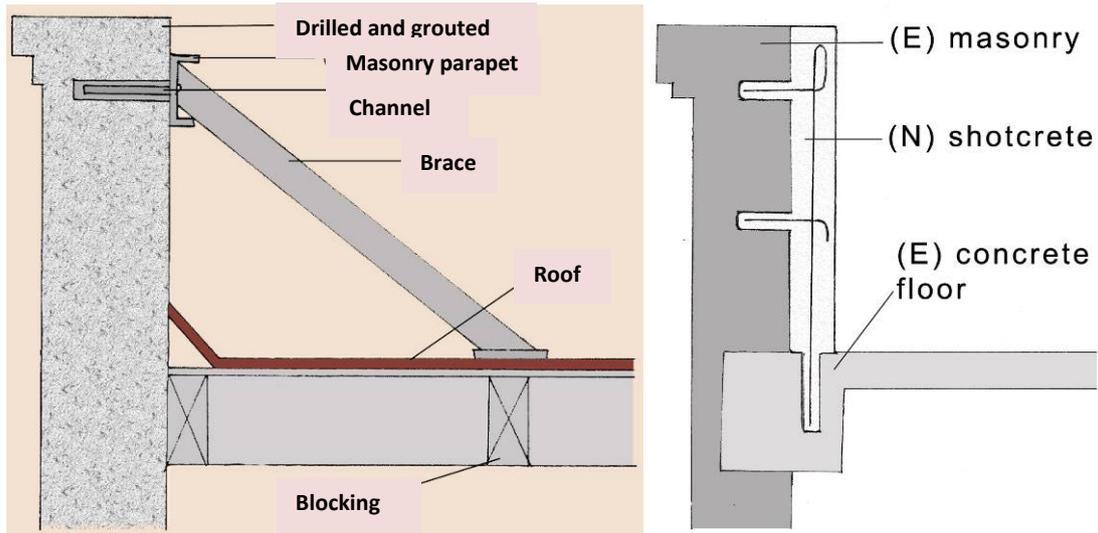
Figure 24 Parapets

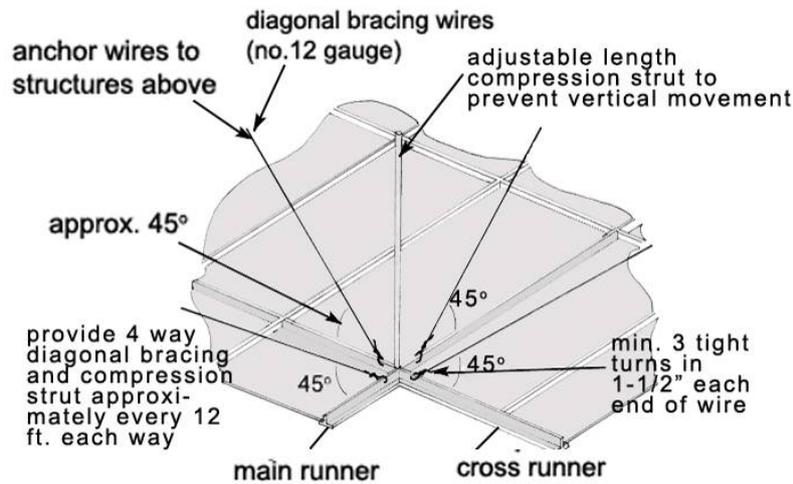
Figure 25 Ceilings

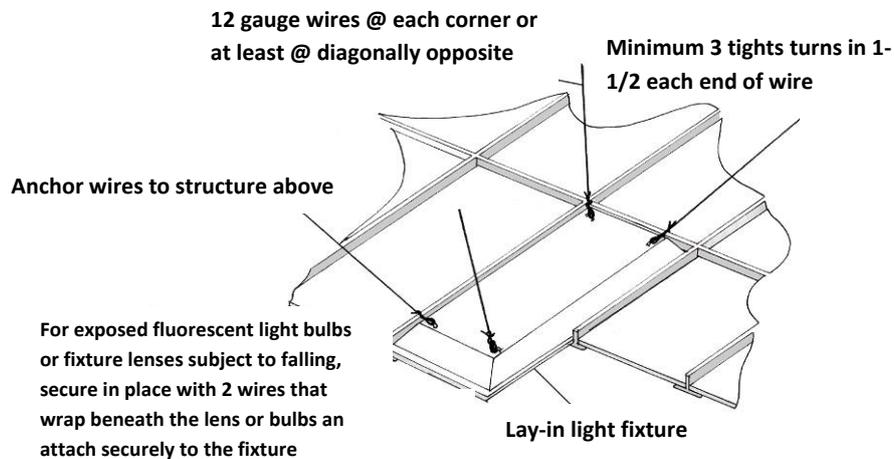
Figure 26 Lighting Fixtures

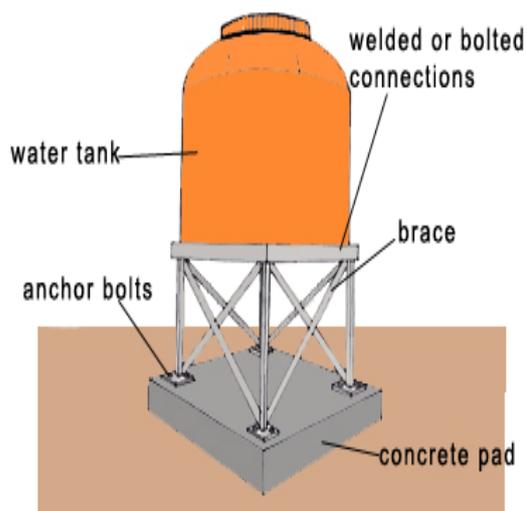
Figure 27 Tank

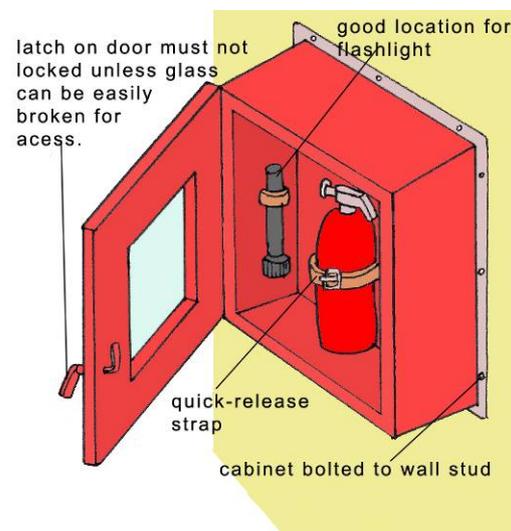
Figure 28 Fire Extinguisher and Cabinets

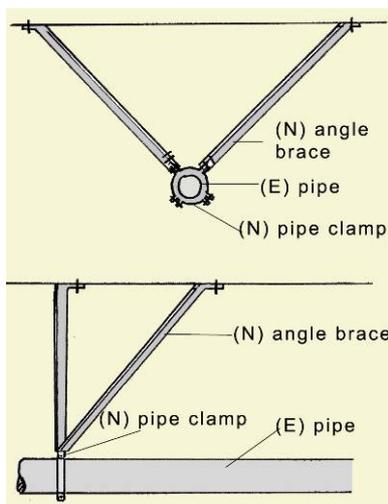
Figure 29 Piping System

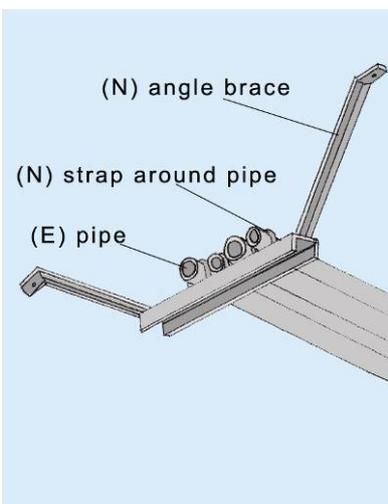
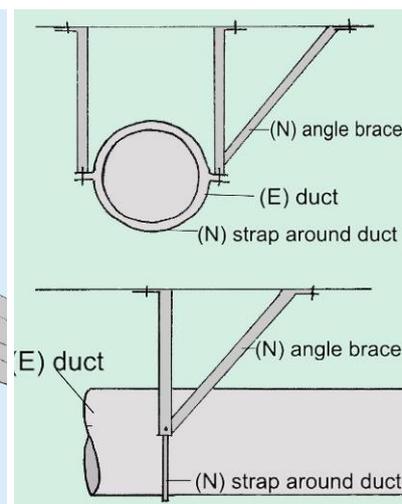
Figure 30 Ducting System

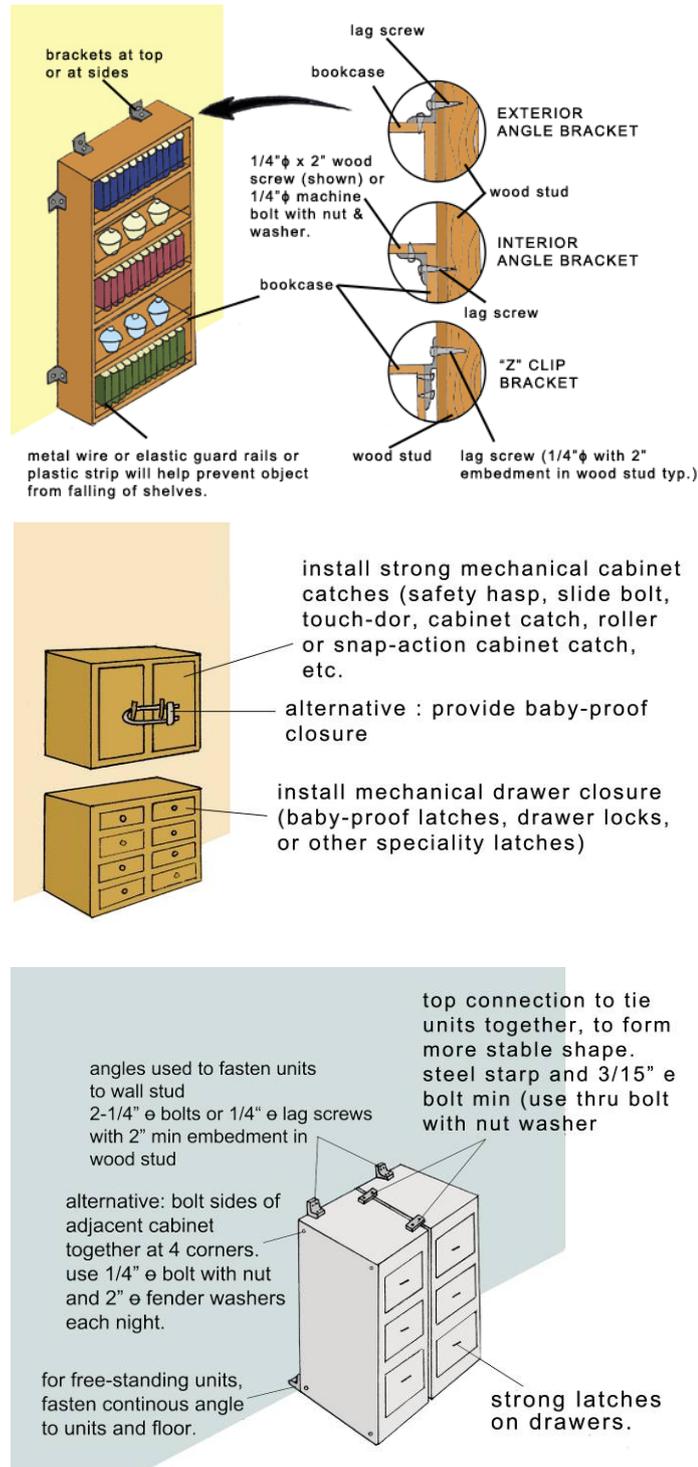
Figure 31 Tall Shelving, Filing Cabinet, Drawer and Cabinet Latches

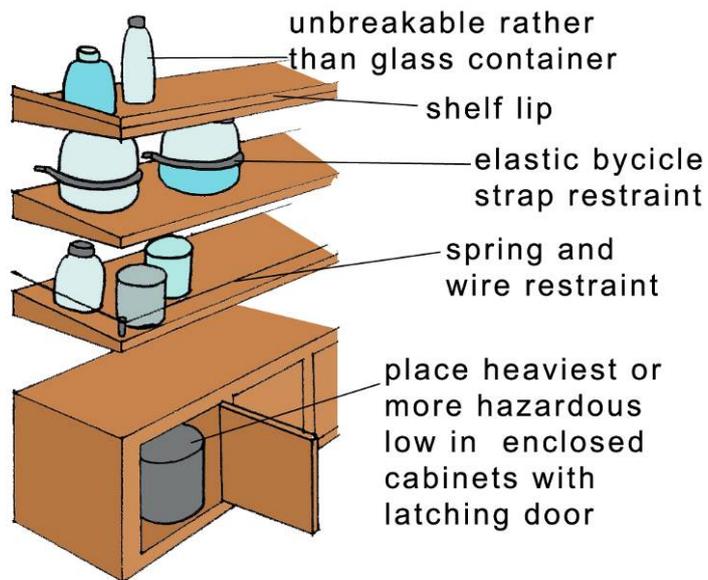
Figure 32 Containers of Hazardous Materials

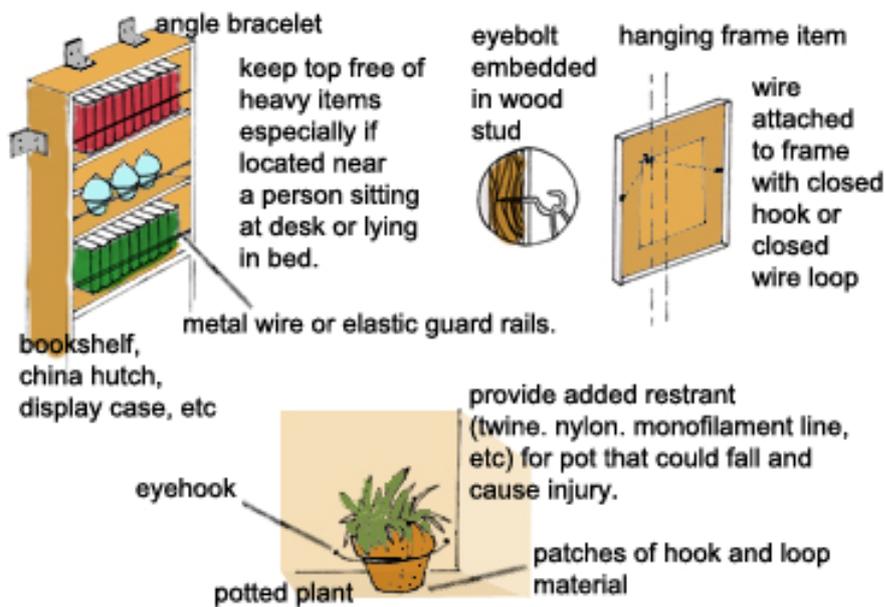
Figure 33 Miscellaneous Furniture

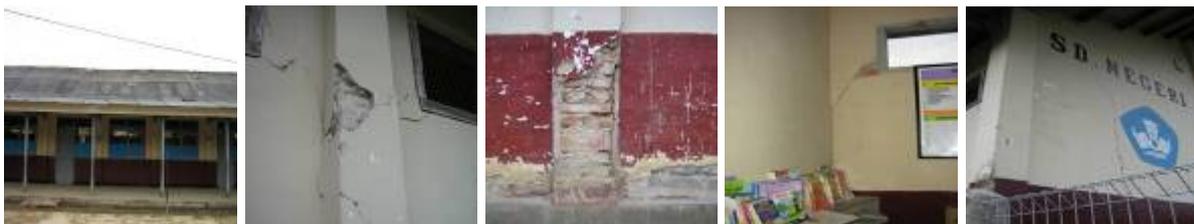
1. Inadequate foundation system (shallow foundation, no tie beam). The foundation system was exposed on some places and no support was provided on areas with eroded soil surface.
2. Inadequate roof framing system, poor wall-roof connection, and poor roof truss element and connection. The roof was in dire need of repair as the construction shown excessive deformation on the top of the building.
3. Damages found on walls, with cracks and gaps found on some places, due to lack of structural elements (beams and columns).
4. Poor materials and detailing on the structures.
5. Poor sanitation facilities.

Figure 35 Existing Condition of SDN Padasuka II

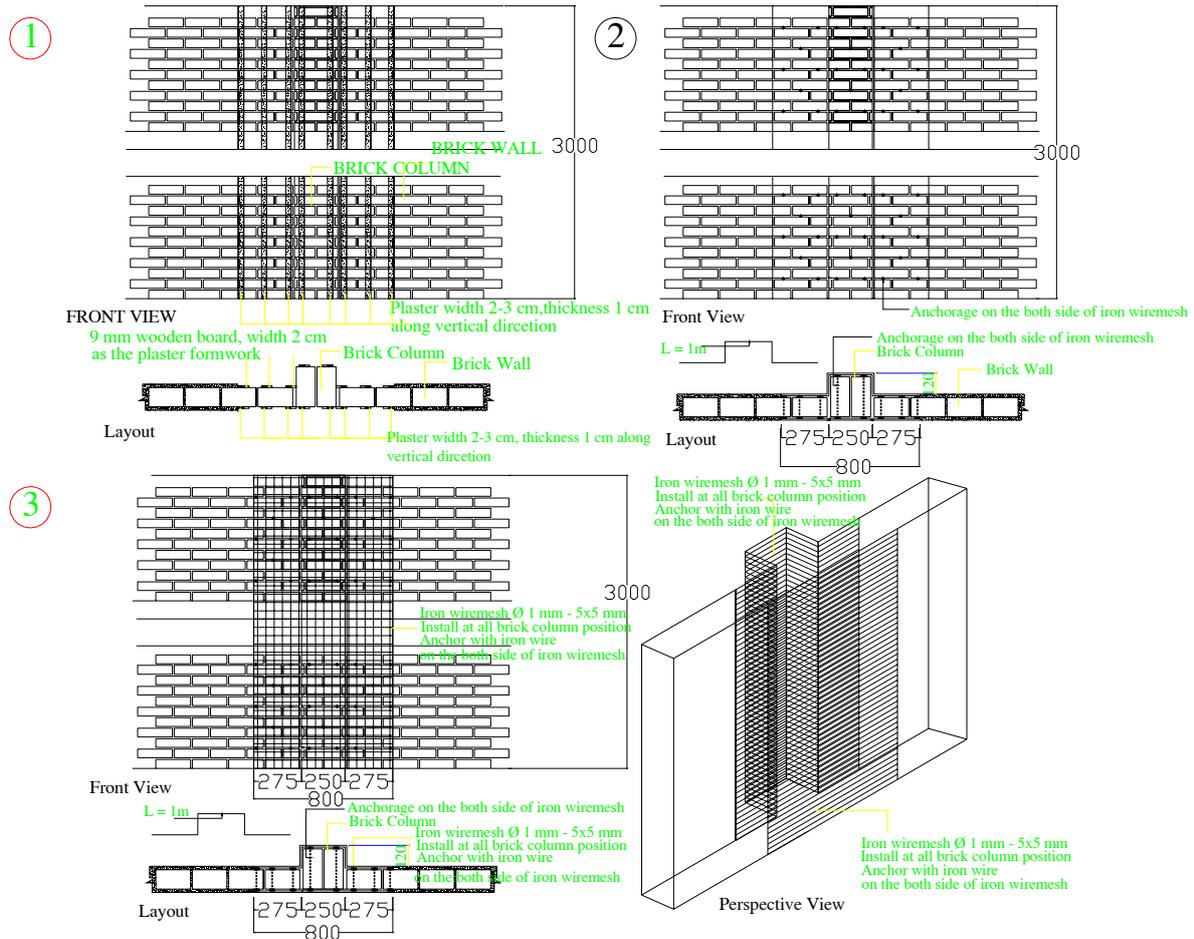
DETAIL OF COLUMN WITH IRON WIREMESH REINFORCEMENT

(a) Retrofitting strategy for columns of SDN Padasuka II

Figure 36 Retrofitting of SDN Padasuka II (Courtesy of PT Teddy Boen Konsultan)

The buildings were retrofitted using iron wire mesh for strengthening wall elements, inserting columns on building corners. The wire mesh was installed in the locations of ordinary beams and columns, as well as diagonally on the perimeter walls. The wire mesh was installed on the both side of the wall and anchored using iron wire. Tie beams were added underneath the walls for strengthening the foundation system. The roof system was retrofitted using proper material and detailing. Repair was conducted for nonstructural elements such as doors/windows and ceilings. Finishing/cosmetic repair and improvement of sanitary facilities were also conducted for the schools buildings

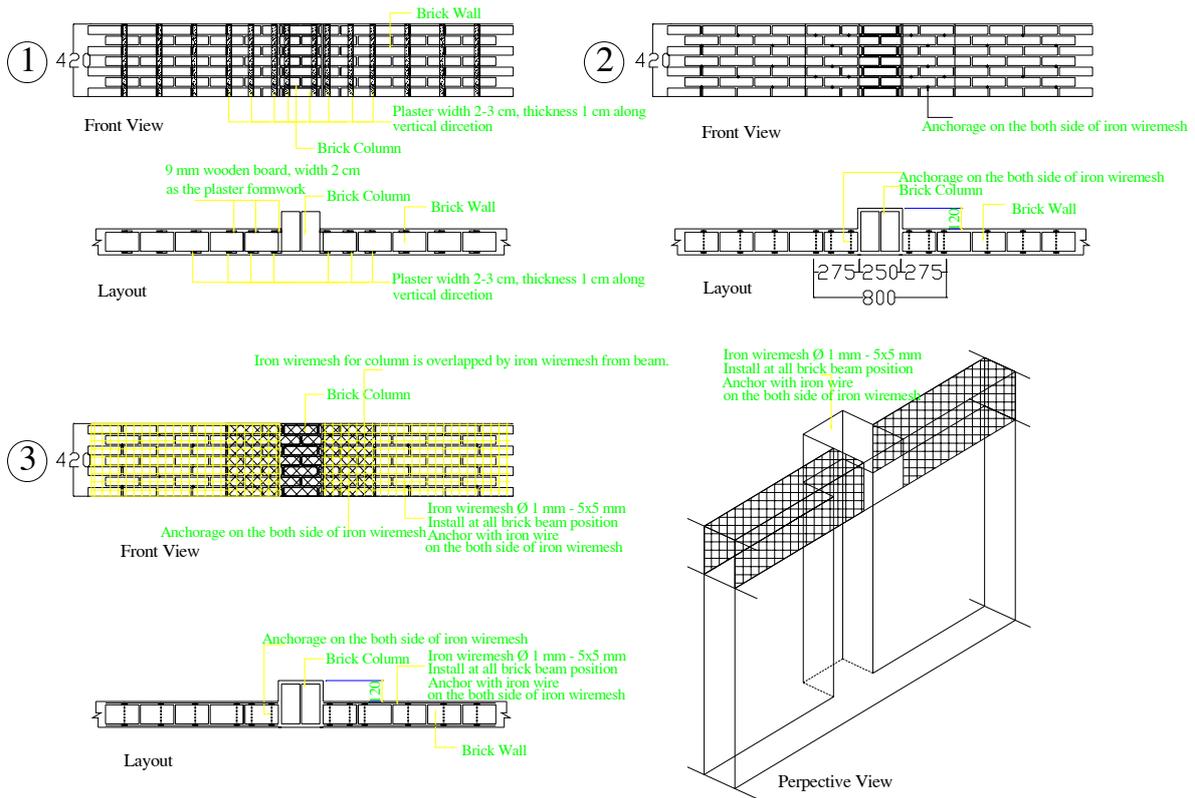
Detail of Beam with Iron Wiremesh Reinforcement

(b) Retrofitting strategy for beams at SDN Padasuka II

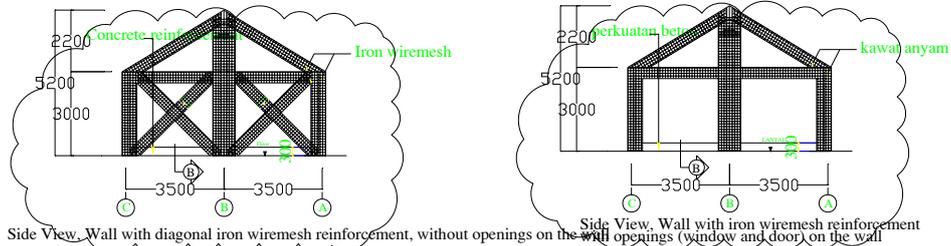
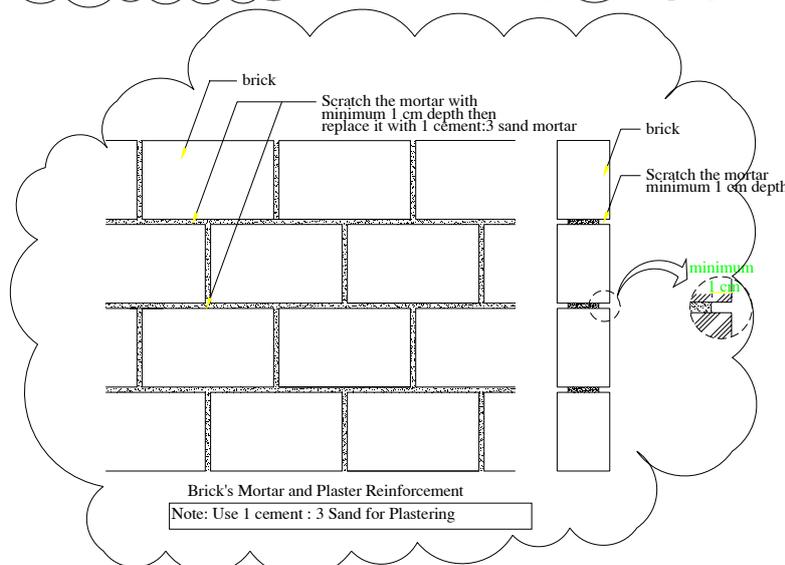
(c) Retrofitting strategy for walls of SDN Padasuka II

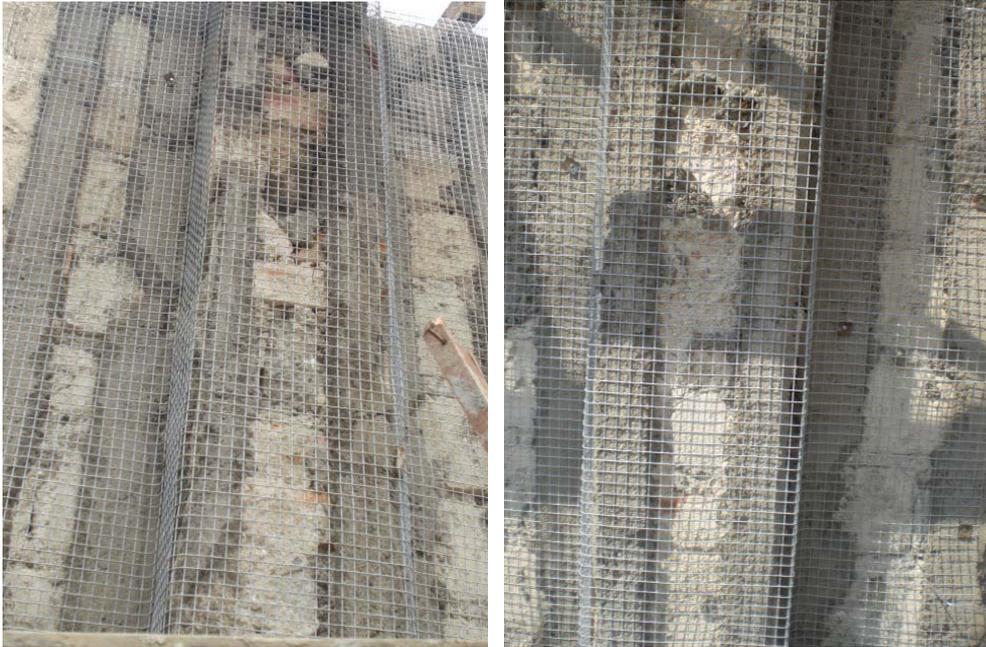
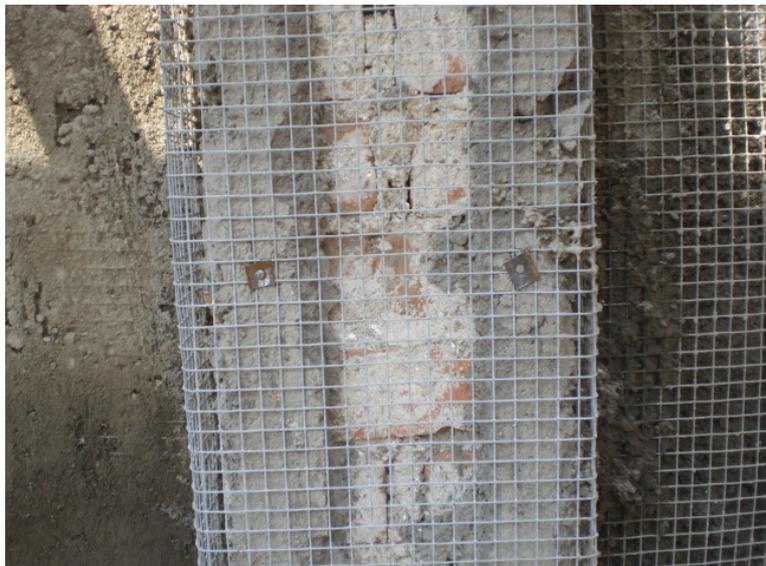
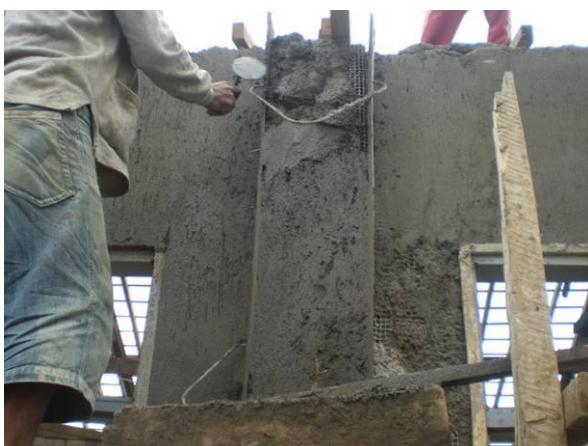
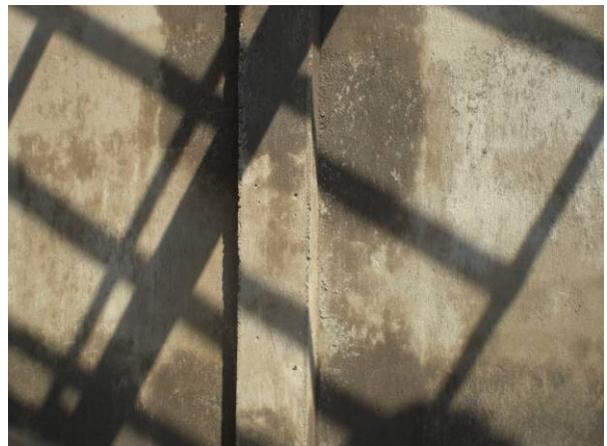
(a) Application of Iron Wire-mesh in Column Position

Figure 38 Retrofitting Works for the Wall

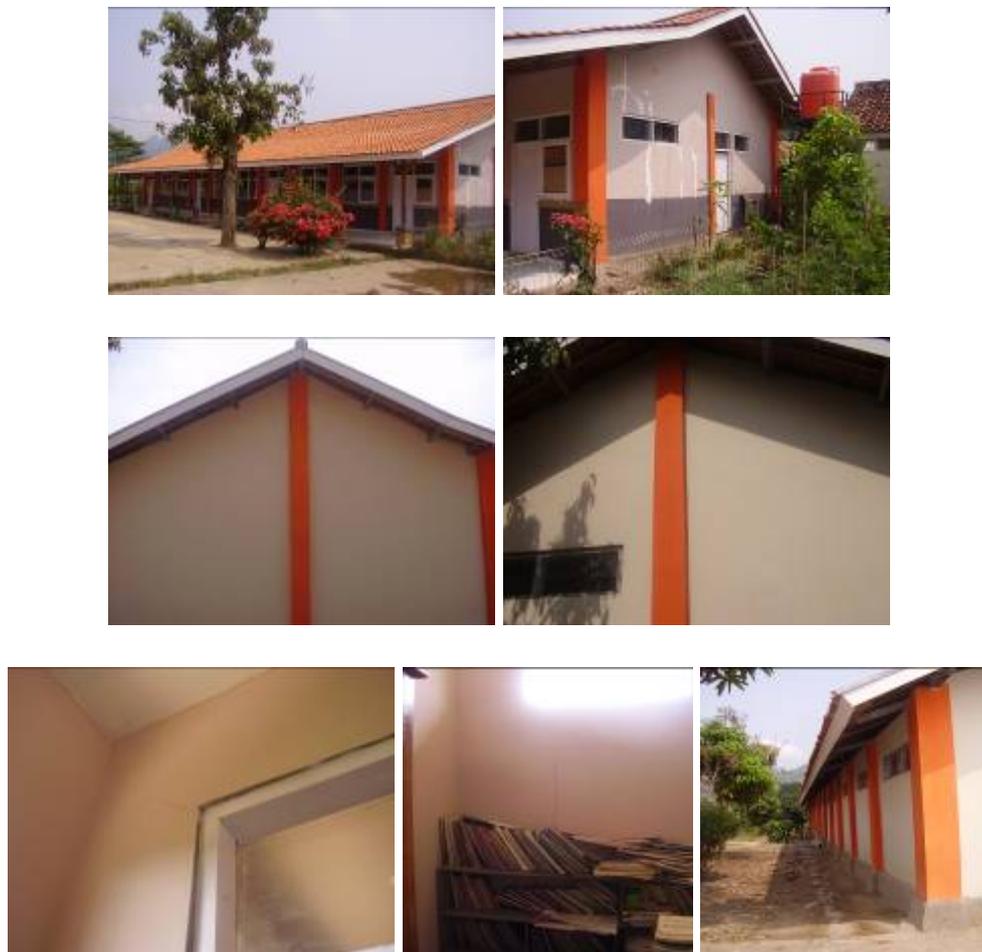
Based on the survey conducted, there was no significant damage on SDN Padasuka II, with only a few non-structural cracks occurred. From the post-earthquake condition, it can be concluded that the retrofitting approaches adopted on SDN Padasuka II has successfully prevented the buildings from major damage. As a comparison, there were some schools and houses located near SDN Padasuka II that were strongly affected by the earthquake shaking. Following figures show the post-earthquake condition of SDN Padasuka II.

Figure 43 Post-earthquake Condition

On September 2nd 2009, approximately 7 months after the retrofitting works completed, a 7.3 Richter scale earthquake occurred with the epicenter located south of Tasikmalaya. The earthquake caused damages on many buildings, including the buildings at Bandung County. Survey was then conducted to evaluate the post-earthquake condition of SDN Padasuka II.

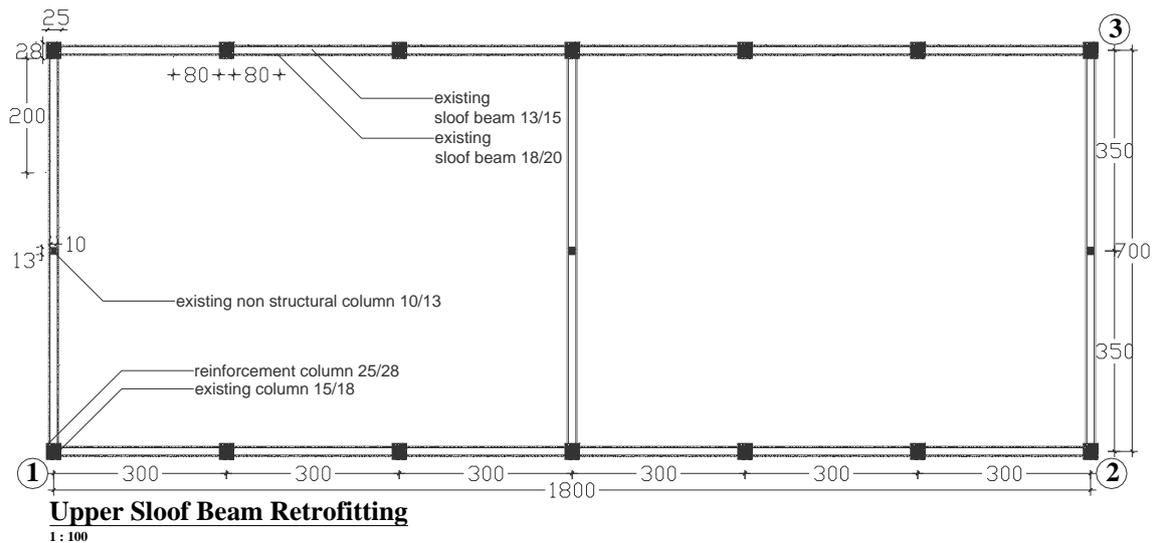
SDN 13 Syamtalira Arun is located at North Aceh. The school building consists of 2 rooms. The school has approximately 400 students. In general, the structural system before retrofitted was reinforced concrete frames with infill masonry walls.

Figure 44 SDN 13 Syamtalira Arun Layout

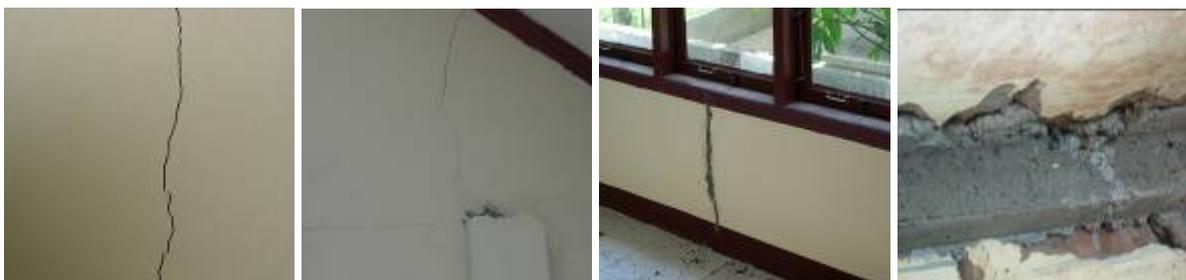
1. Cracks on walls
2. Cracks on structural member
3. Poor workmanship
4. Poor quality construction

Figure 45 Existing Condition of SDN 13 Syamtalira Arun

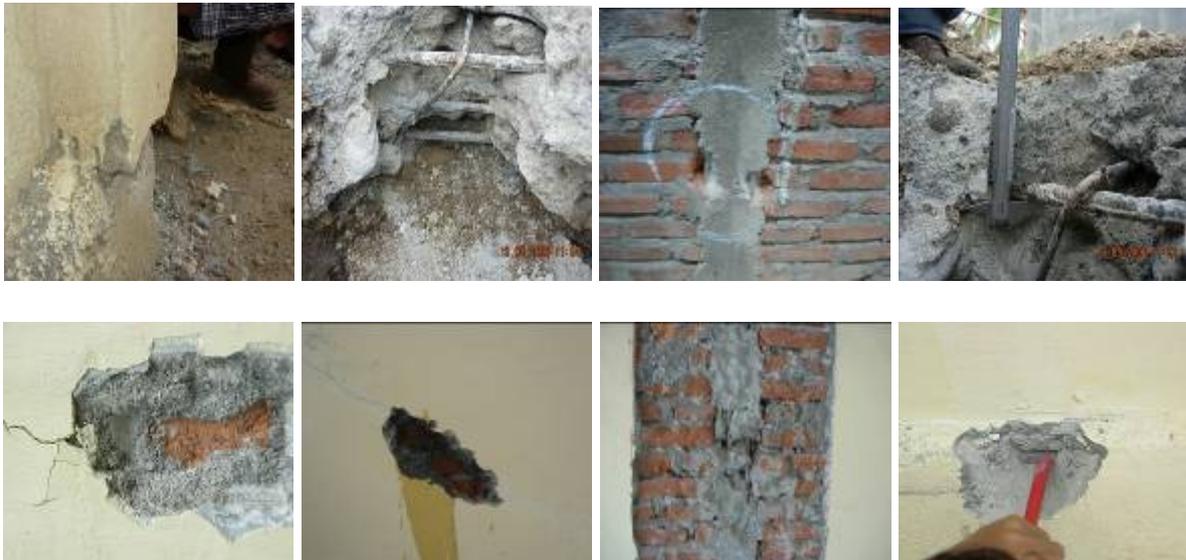
- Rapid visual inspection and assessment
- Collection of design and drawing
- Topographical information of site
- Site measurement of main structural member
- Inspection of cracks and location
- Judgment of the construction quality
- Evaluation of workmanship
- Inspection of material used and its quality

Figure 46 Visual Assessment
