MANUAL ON
“RETROFITTING OF EXISTING VULNERABLE
SCHOOL BUILDINGS – ASSESSMENT TO RETROFITTING”
PART I

This book is developed by Save the Children, Construction Quality & Technical Assistance (CQTA)

Center for Disaster Mitigation - Institute of Technology Bandung (CDM -ITB)

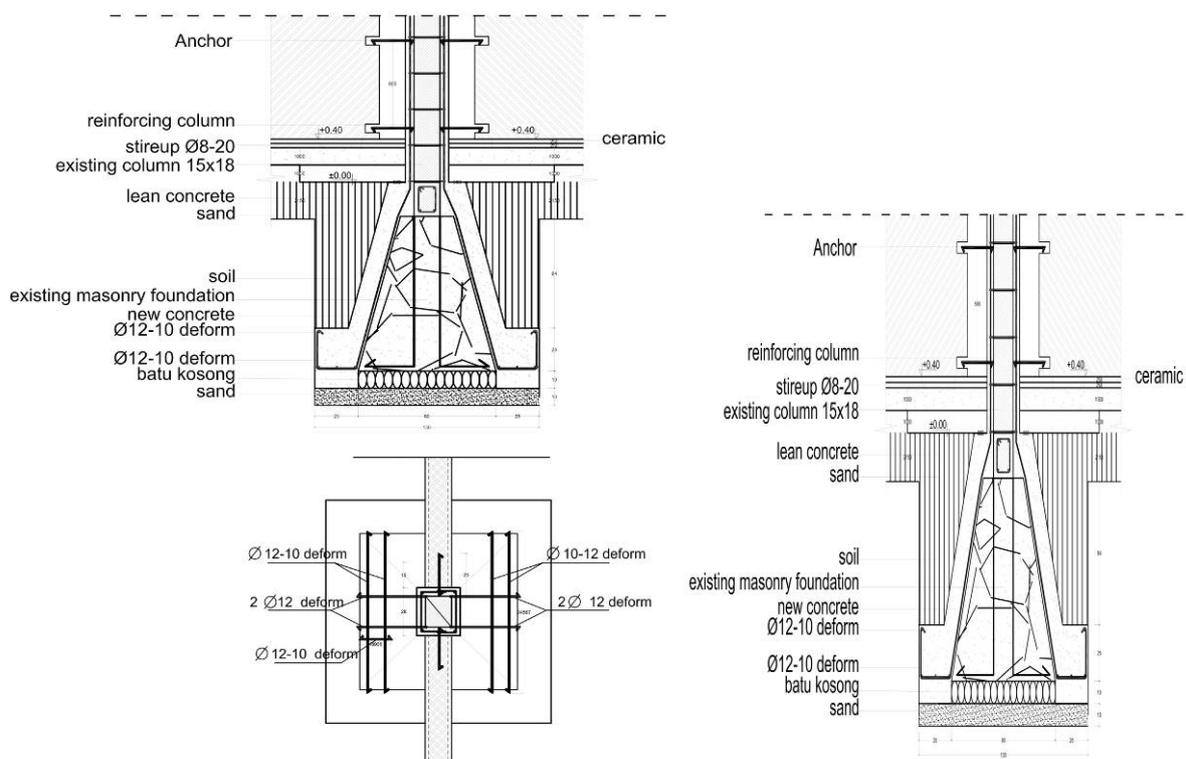
Figure 48 Retrofitting of Foundation

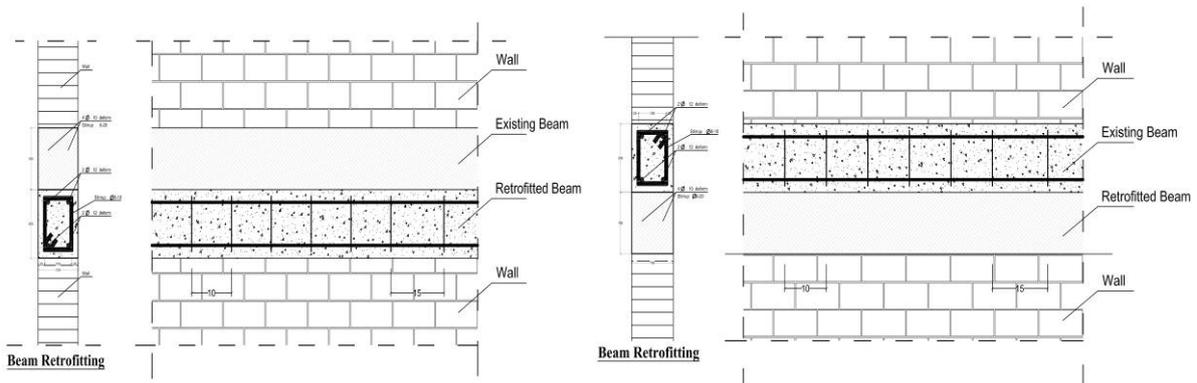
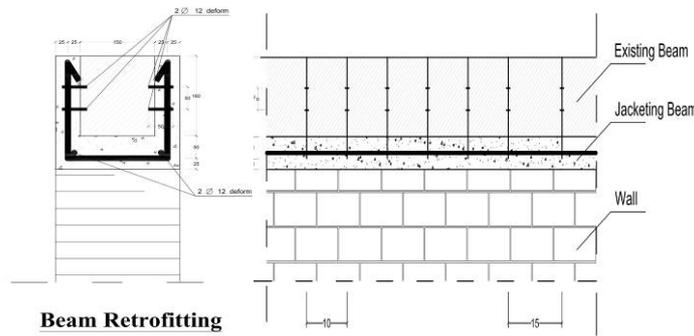
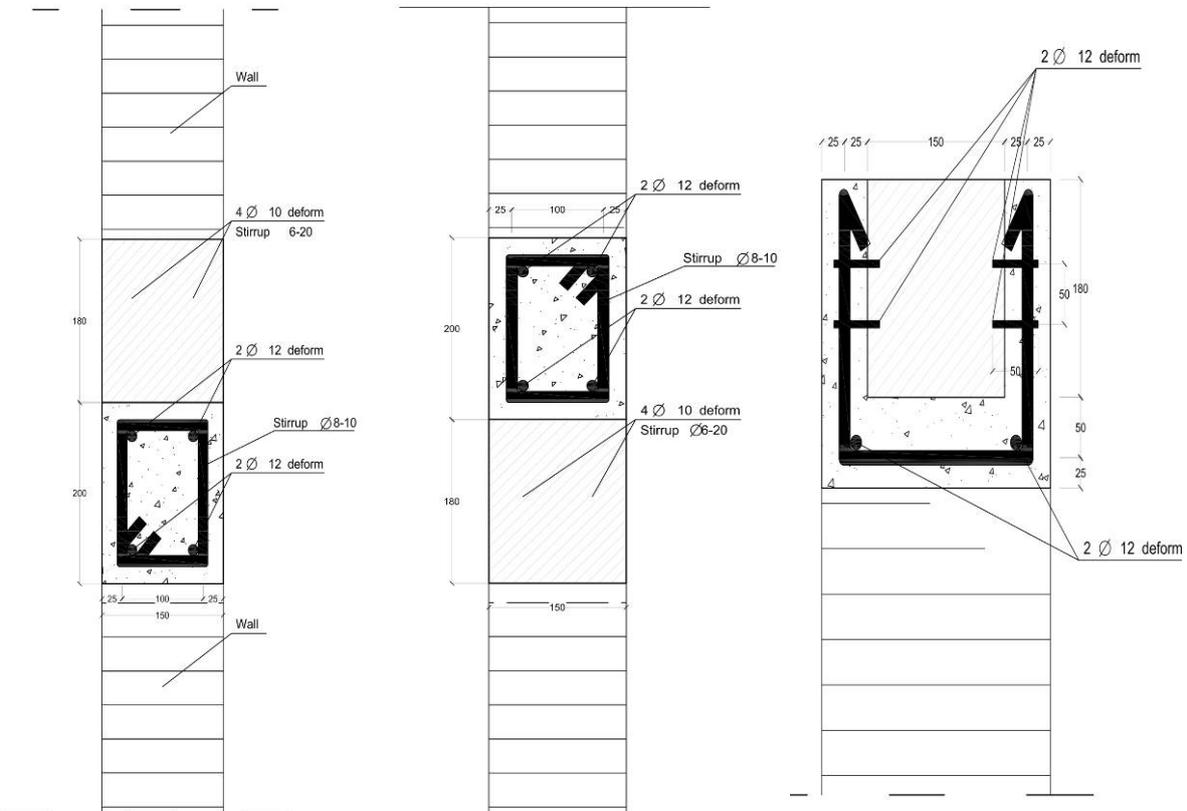
Figure 49 Retrofitting of Beam

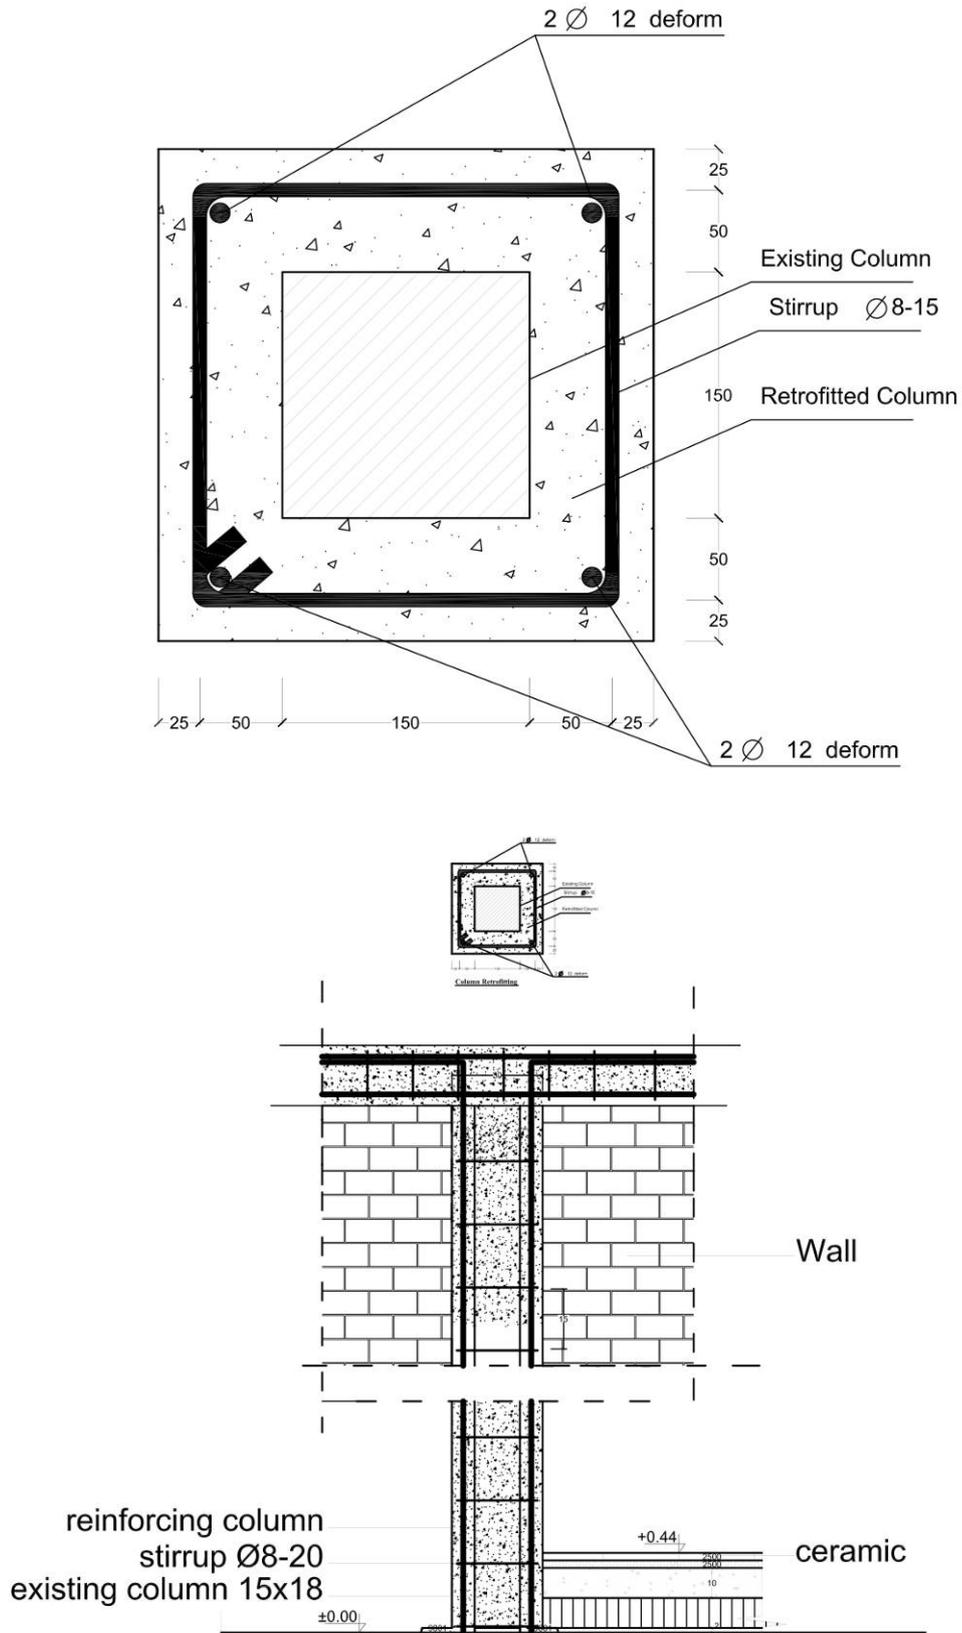
Figure 50 Retrofitting of Column

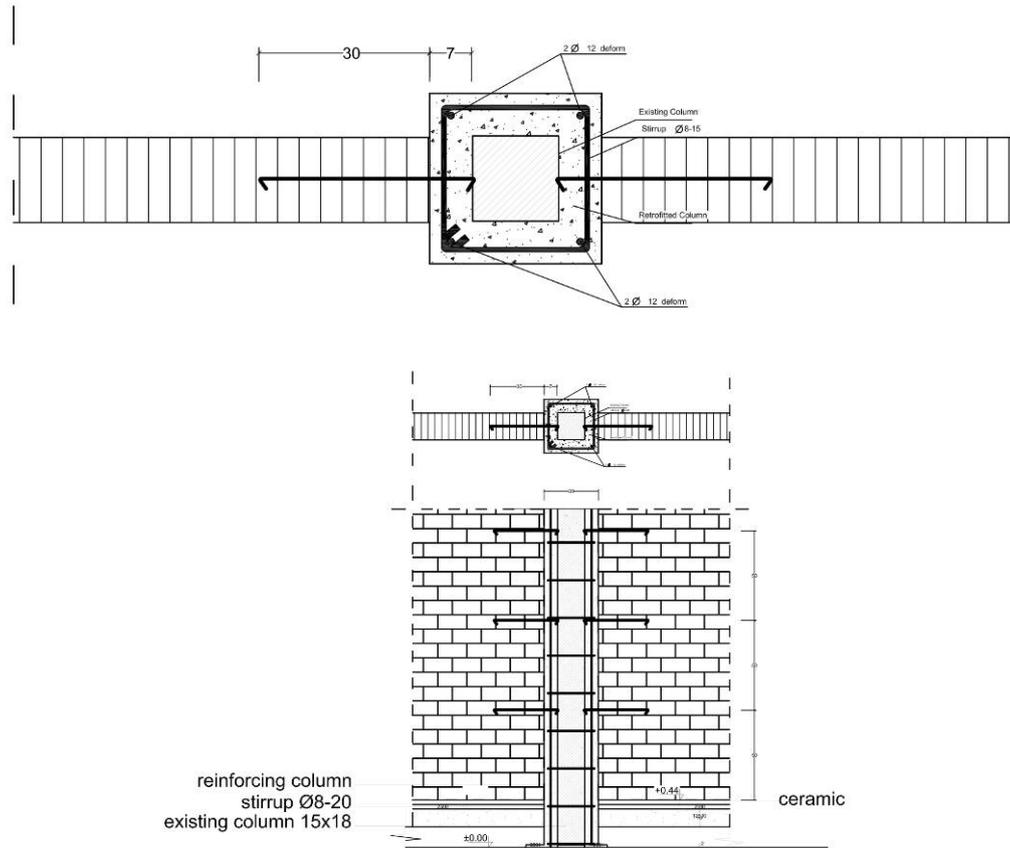
Figure 51 Retrofitting between Wall and Column

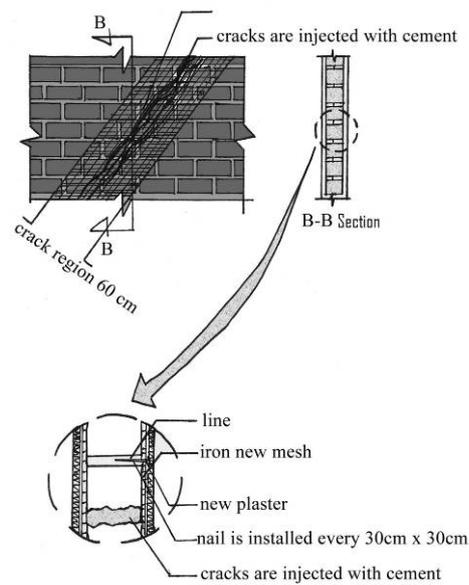
4) Corrective measure on cracks

Figure 52 Cracks Injection
